A 17th Century Sluice Raises New Questions at Grand-Pré

**Les Cahiers de la Société historique
acadienne, vol. 40, no 3, septembre
2009, p. 100-128**

Jonathan Fowler

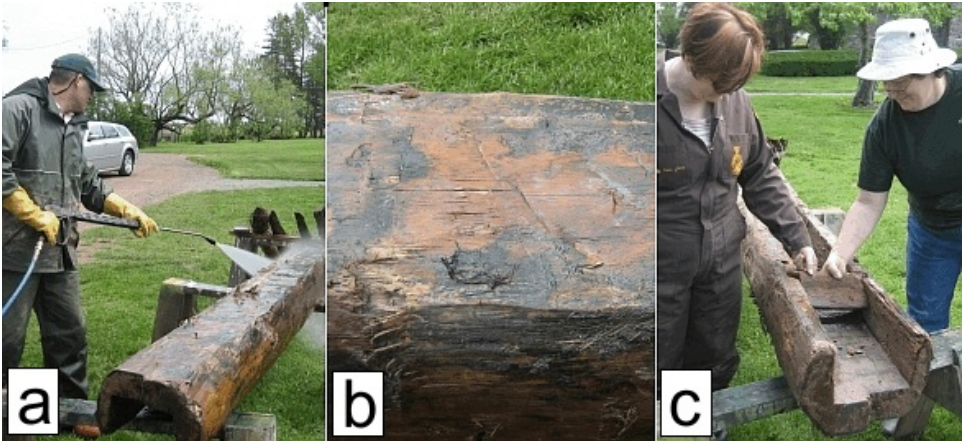
FIGURE 2: The initial cleaning of the sluice. (a) Stephen Coldwell, of Parks Canada's Grand-Pré staff, cleans the mud from the underside of the sluice with a pressure sprayer. The end of the sluice closest to the camera is the finished end through which the water exited the sluice when it was working. (b) Tool marks still visible on the flattened underside of the sluice. (c) Amanda Thomas (left) and Colleen Day (right) display the intact clapet. Photos courtesy of Victor Tétrault.

In the meantime, cleaning with a pressure sprayer (Figure 2a)¹ offered the first good look at the sluice, revealing it to be a single hollowed out log, still bearing the tool marks of its makers (Figure 2b). The wooden clapet was still in good working order (Figure 2c), but owing to its delicate (and highly portable) nature, it was removed to the Parks Canada Conservation Lab in Dartmouth where it would be treated separately.

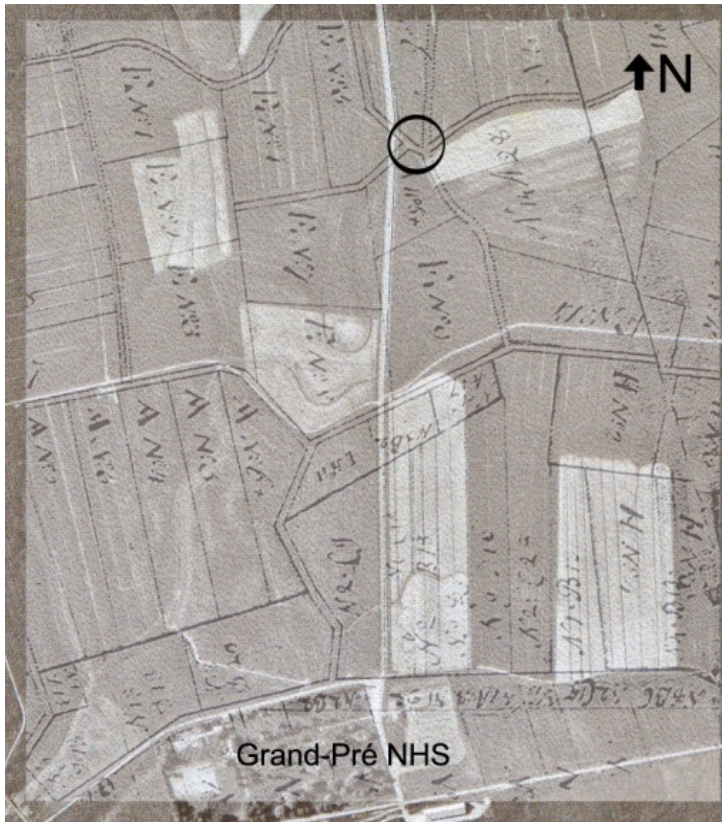
FIGURE 4: Site location (centre of black circle) on compiled air photo and 1760s map. This plan is not registered, and is intended for illustration only. The plan overlay is approximately scaled and modified to 40% opacity. SOURCE: A19985-170, 1967.

Sherman Bleakney’s model of the Acadian dyking sequence at Grand-Pré benefited from a surviving survey of the marsh drawn up in the 1760s by John Bishop (2004, 75).⁶ This large scale plan is probably the single most important source available for understanding the Acadian dyking system at Grand-Pré, for it plots not only the network of dyke walls as they existed in the early phase of New England Planter settlement, but also various roadways and field divisions, many of which likely date to the Acadian occupation. By reconsidering our site location in light of this map, with one eye still on Bleakney’s model, it becomes apparent that the find spot is situated at an intersection of structures that may be either roads or dykes, or some combination (Bleakney interprets them as roads), and more specifically at a point where one of these structures crosses a creek.⁷ Figure 4 displays an overlay of the historical map with a 1967 aerial photograph. The farm road under which our sluice was found remains in use to this day, although it shows up better in an aerial photograph from 1945 (Figure 5).

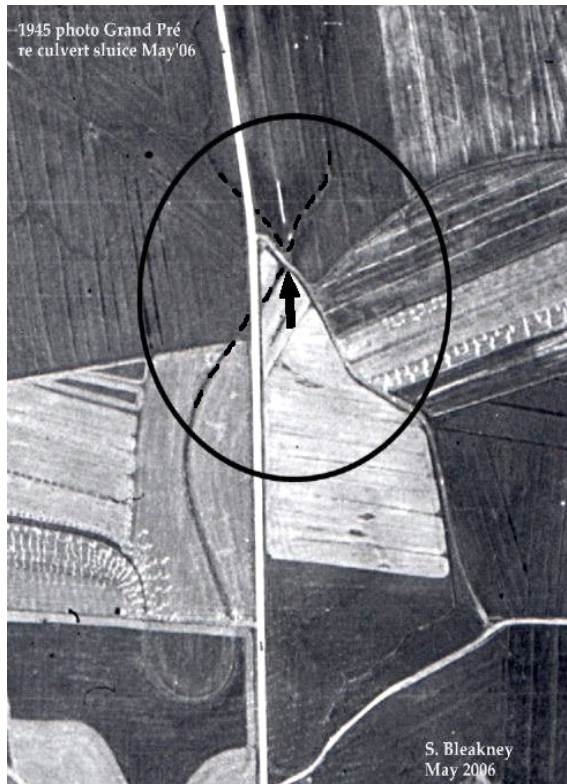
FIGURE 5: The roadway (white line) under which the sluice was discovered as seen from the air in 1945. The black arrow indicates the find location at the point where the road crosses the creek bed (the course of the creek is indicated by dashed lines). North at top. SOURCE: Sherman Bleakney (A8645-53, 1945). ©Department of Natural Resources Canada. All rights reserved.

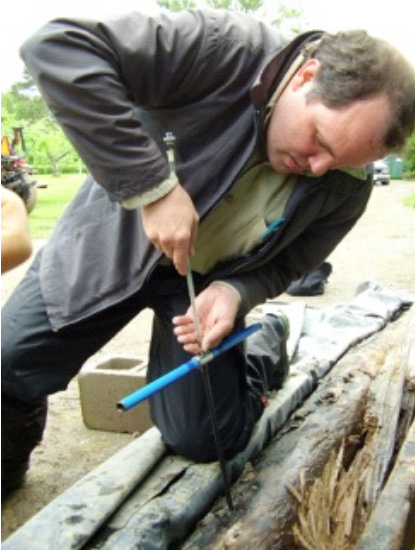
FIGURE 6: André Robichaud of Mount Allison University’s Dendrochronology Lab extracting a tree ring sample from one of the posts.

What’s more, if the last growth ring on the sample is present, the actual year in which the wood was cut may be determined (Renfrew and Bahn 2008, 138-141). André visited Grand-Pré on 9 June, 2006, to take samples from the recovered portion of the sluice and the two associated posts (Figure 6). Before the tree ring dates could be determined, however, the field season was upon us. Armed with assurances derived from our understanding of landscape history, but not without concern, we moved ahead with the recovery process.

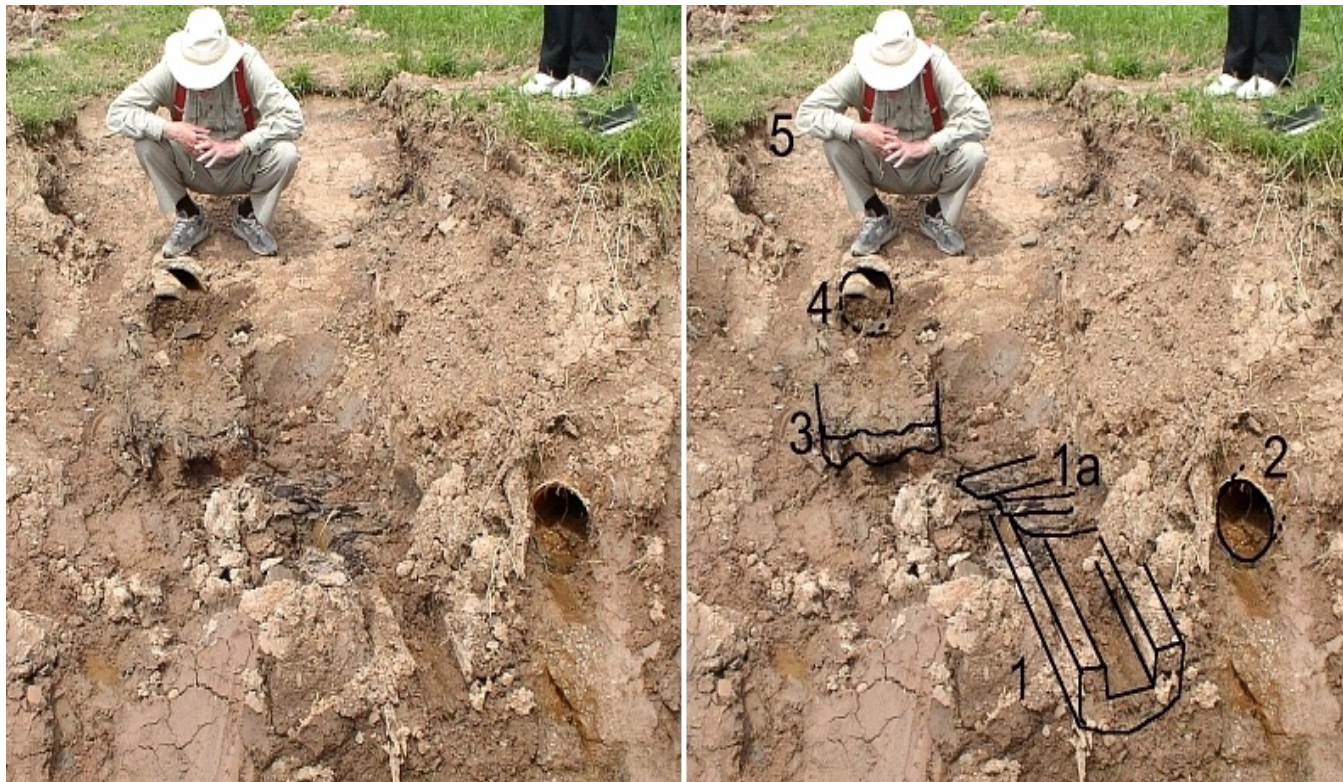
FIGURE 7: The rough cut side of the excavated drainage ditch, revealing its archaeology, as it appeared on 26 May, 2006, camera facing north. Here we may see: (1) the sluice, with its broken end exposed; (1a) elements of the poorly preserved plank cover of the sluice; (2) a modern plastic drain pipe; (3) portions of another wooden feature (identity unknown at the time of this visit); (4) a concrete drain pipe bedded on top of the mysterious wooden feature; and (5) Dr. Sherman Bleakney (for scale).

It is worthwhile considering the appearance of the *in situ* remains prior to excavation, for the excavator, in cutting his drainage trench across the marsh, had already encountered more than just our sluice here. As Figure 7 demonstrates, the cutting exposed a long history of hydrological engineering activities at this location. As far as we could determine, the oldest and deepest element of these works was the sluice itself (Figure 7, #1), the top of which was found at about 1m below the present surface. By tracing the grain of the wood through the clay, it was possible to observe that some of the planks covering the sluice also remained *in situ* (Figure 7, #1a), but in a very poor state of preservation. Just above the sluice, to the east, the broken end of a plastic pipe dribbled water (Figure 7, #2). The recent installation of this pipe must have come precariously close to the sluice, but appears to have not even grazed it.⁸ Curiously, adjacent to the sluice to the west, bedded slightly higher in the profile, additional wooden elements could be seen (Figure 7, #3). This was a cause of much speculation. Finally, a concrete pipe, another fairly recent installation, though probably not as recent as the plastic pipe, appeared to be bedded almost directly on top of these curious wooden elements (Figure 7, #4). The potentially problematic component of this crude cross section was the additional wooden elements (#3), which frankly puzzled us at the time.

ran underneath it. This relationship was supported by the discovery of a single wire nail associated with the channel, which suggests it was installed no earlier than the 1860s or 1870s (Nelson 1968, 10). Traces of this structure ran the whole length of the sluice, but appear to have been badly damaged by the later installation of the concrete pipe (Figure 7, #4).

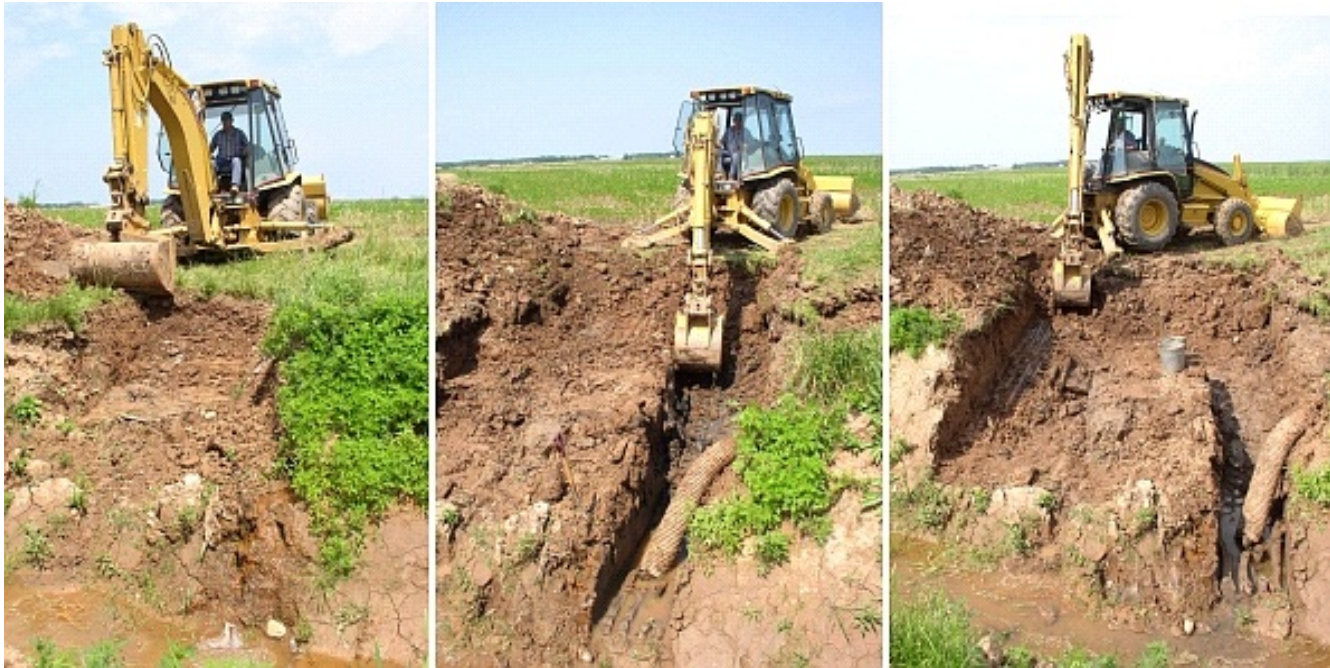
FIGURE 8: Three photographs showing the progress of mechanical excavation (left to right) to determine the extent of the in situ sluice (camera facing north).

The salvage excavation commenced on 14 July. A backhoe removed the overburden and delineated the archaeological features (Figure 8) and the rest of the day was spent on detail work with hand tools.⁹ It soon became apparent that the mysterious wooden elements immediately west of the sluice were mirrored by another set above the sluice on the east side. Further detailed excavation on 15 July revealed this to be a series of poorly preserved spruce poles bedded horizontally just above, and parallel to, the sluice. The discovery of these poles, which had been laid out side-by-side, above and parallel to the line of the sluice, appeared to have been designed as a hardened surface over which one could travel. Might this have been the remains of a corduroy road (Figure 9)? (An additional set of labelled close-up images is presented as Figure 10). If so, it seems only to have extended the width of this narrow creek, and even within these tight confined portions seem to have been removed. For example, the poles immediately above the center line of the sluice were missing, the intervening space filled with a tangle of brush and wood debris.

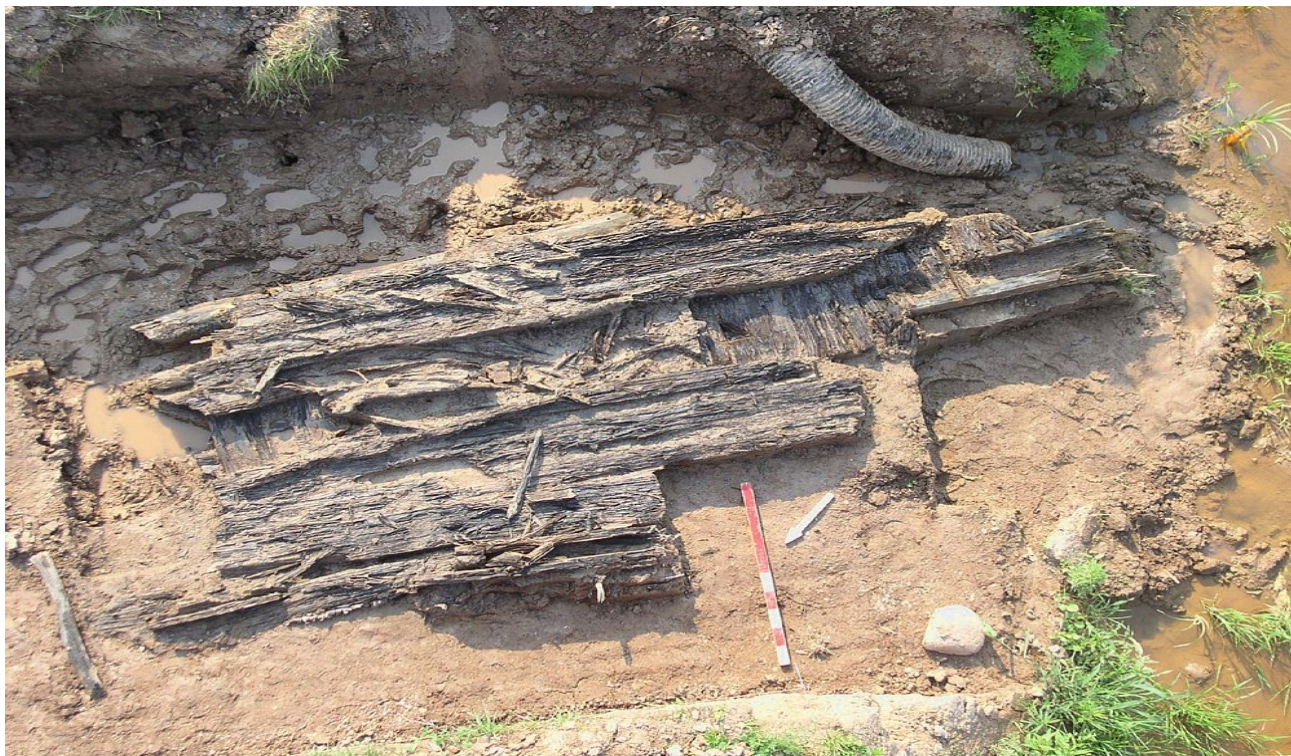
FIGURE 9: The cleaned sluce feature prior to the removal of the corduroy road remnants.

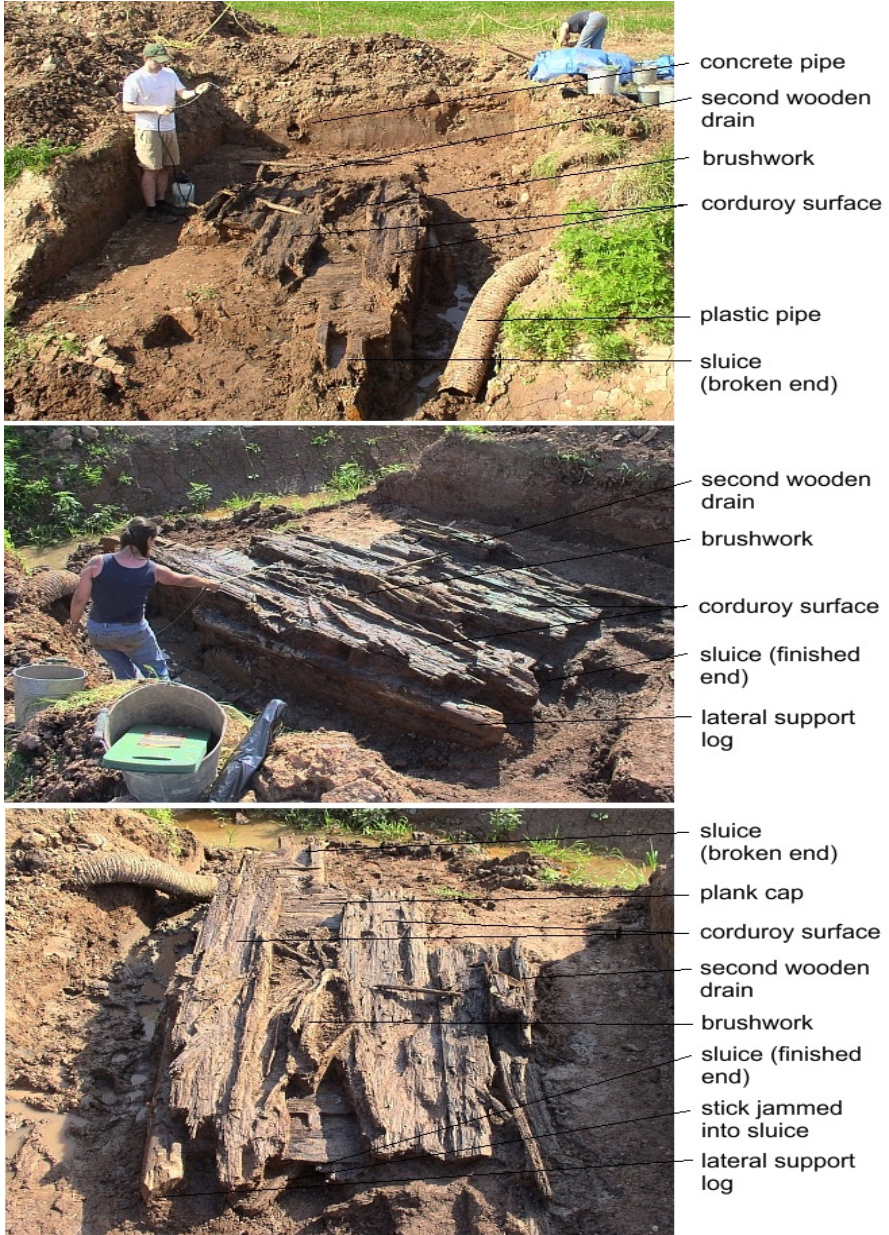
FIGURE 10: The sluice and corduroy features at the end of the initial phase of excavation; (top) with Robert Shears (camera facing north); (middle) with Sara Beanlands (camera facing southwest); (bottom) camera facing south.

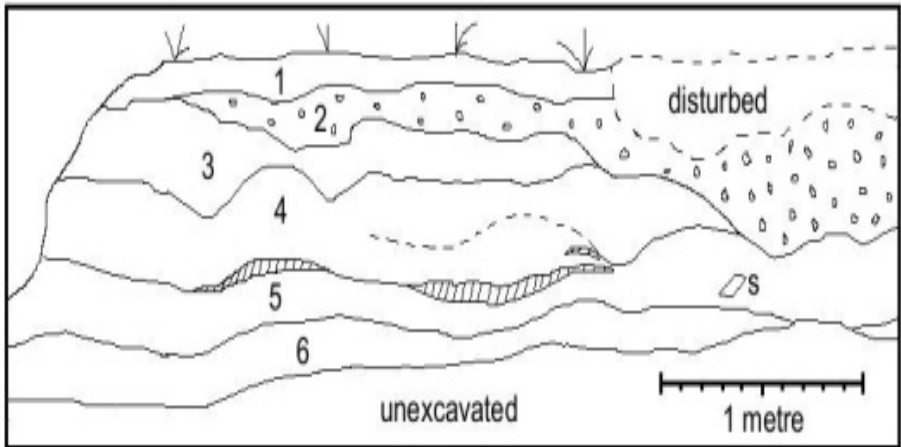
FIGURE 15: West profile: (1) sod; (2) crushed rock; (3) red clay, blocky structure; (4) brown clay; (5) grey clay; (6) red clay. Hatched layers represent traces of wood likely associated with the western end of the brushwork or decayed corduroy. The disturbed area represents a loosely consolidated portion of the profile that collapsed during machine excavation.

It stands to reason that if the wooden elements picked up in the west profile (hatching, Figure 15) relate to the brushwork and/or “corduroy structure” overlaying the sluice, then the layers immediately beneath (#s 5 and possibly 6) represent either natural marsh development beside the creek at the time of installation, or fill material placed within it during installation. As these are essentially homogeneous sediments, they are probably natural.
