Archaeological Research Report
HERITAGE RESEARCH PERMIT A2006NS53

Archaeological Salvage Excavation
of a 17th-Century Acadian Sluice
from the Grand-Pré Marsh

24 December 2006

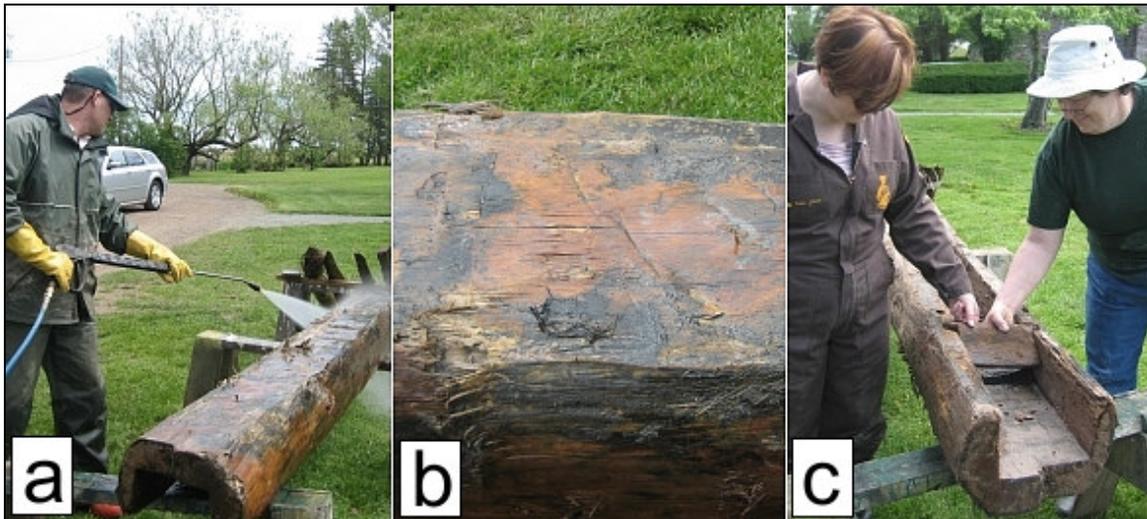
Figure 2: The initial cleaning of the sluice. (a) Stephen Coldwell, of Parks Canada’s Grand-Pré staff, cleans the mud from the underside of the sluice with a pressure sprayer. The end of the sluice closest to the camera is the finished end through which the water exited the sluice when it was working. (b) Tool marks still visible on the flattened underside of the sluice. (c) Amanda Thomas (left) and Colleen Day (right) display the intact clapet. Photos courtesy of Victor Tétrault.

Above all, I remain perplexed by the fact that this sluice was provided with a clapet (**Figure 2c**). Why should a culvert, powered by the force of gravity acting upon the water

in the creek, require a one-way valve to function? Nature would already have provided for a southerly flow through the creek bed. The installation of the clapet presumes the opposite could occur and, moreover, that the builders were keen to prevent it. The most obvious cause of such an inundation is the tide, but the tide should have come nowhere near the south side of this sluice. Spring flooding might have caused the creek to fill and back up, and the one-way valve would at least have prevented this, speeding the rate at which the land dried to the north of the road and sluice, and possibly allowing those dryer fields to be sown earlier. Whatever the builders' intentions, this discovery adds one more layer of complexity to our knowledge of Acadian engineering practices.

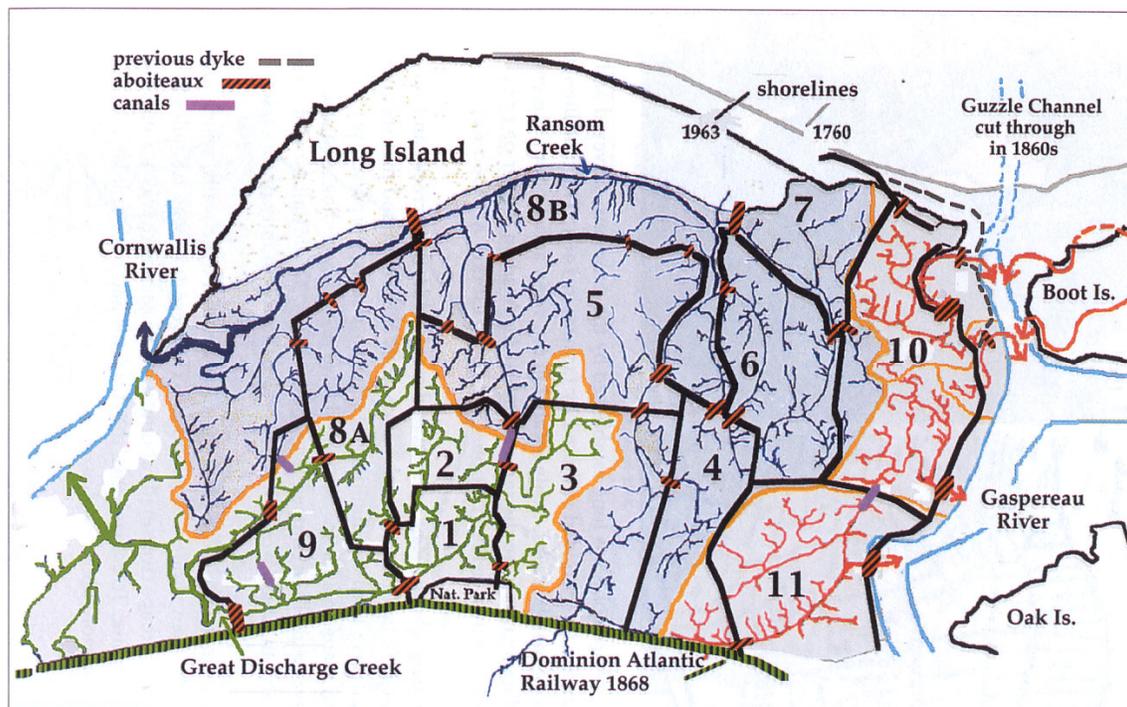
Figure 3: Bleakney's developmental model of the Acadian dyking sequence at Grand-Pré. The black lines depict Acadian dyke walls while the coloured, curved lines indicate the marsh creeks that form the marsh's natural drainage system. The numbers indicate the sequence in which each section of the marsh was dyked. Our sluice was associated with the deeply curved creek just to the left of the top of the number 3. Source: Bleakney 2004, p. xxiii.

Our present knowledge of the cultural history of the Grand-Pré marsh derives largely from Dr. Sherman Bleakney's recent work, in which he proposes a developmental model for understanding the Acadian dyking sequence (2004). Bleakney's model is based primarily on a study of the marsh's natural drainage system, over which he superimposes a map of the largely relict network of dyke walls. This represents a significant improvement over the initial efforts by Cameron (1958), who focused on plotting the dyke network through aerial photography but ignored the underlying drainage patterns that caused the system to function. If Cameron gave us the bare bones, Bleakney stitched them up in flesh and charted out a circulatory system. With the drainage system and dyke walls accurately plotted, a few basic assumptions finish the job: 1. newer dyke walls will abut older dyke walls (or the upland) and not vice-versa; and 2. water flows downhill. Bleakney's resulting sequence of enclosures is shown below (**Figure 3**).

As Figure 3 demonstrates, the recently discovered sluice comes from an area *within* block 3 rather than along the line of the dyke wall. This is very peculiar given that an aboiteau is, by definition, a component – indeed a fundamental component – of the dyke network itself. As such, it ought to be connected to a dyke wall. A few additional words by way of historical context will not be out of place here.

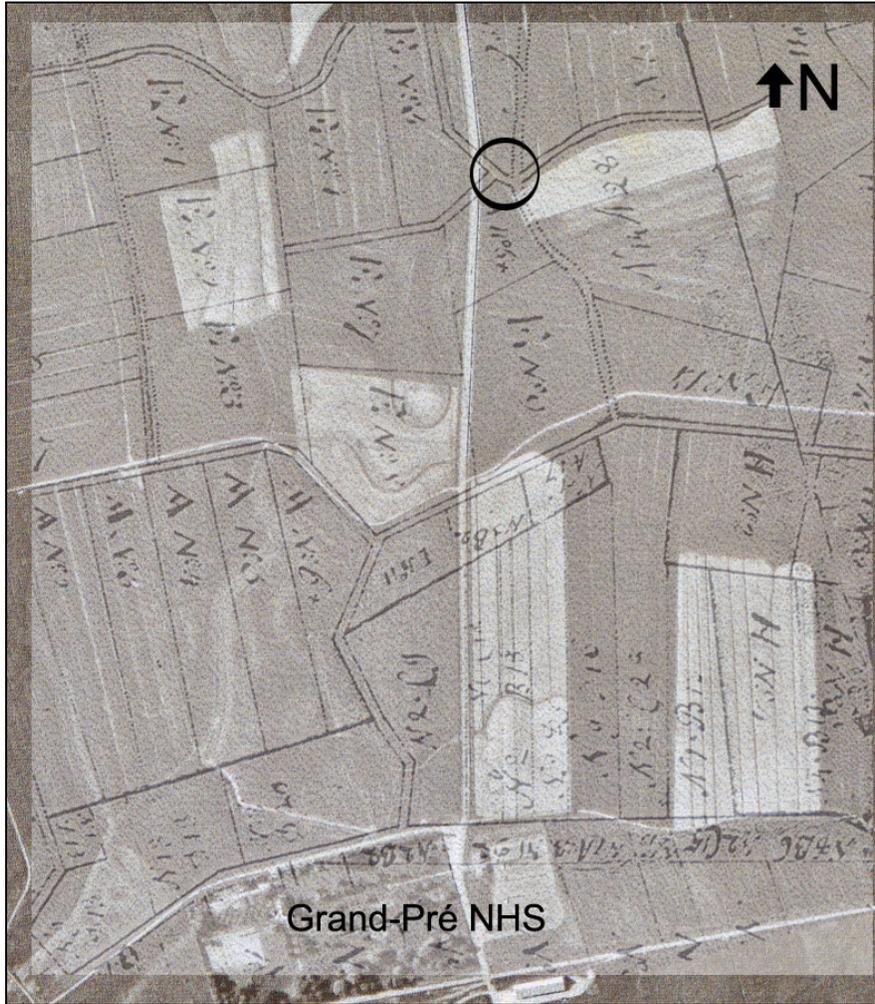
Figure 4: Site location (centre of black circle) on compiled air photo and 1760 map. This plan is not registered, and is intended for illustration only. The plan overlay is approximately scaled and modified to 40% opacity using Adobe Photoshop. Photo source: A-19985-170, 1967.

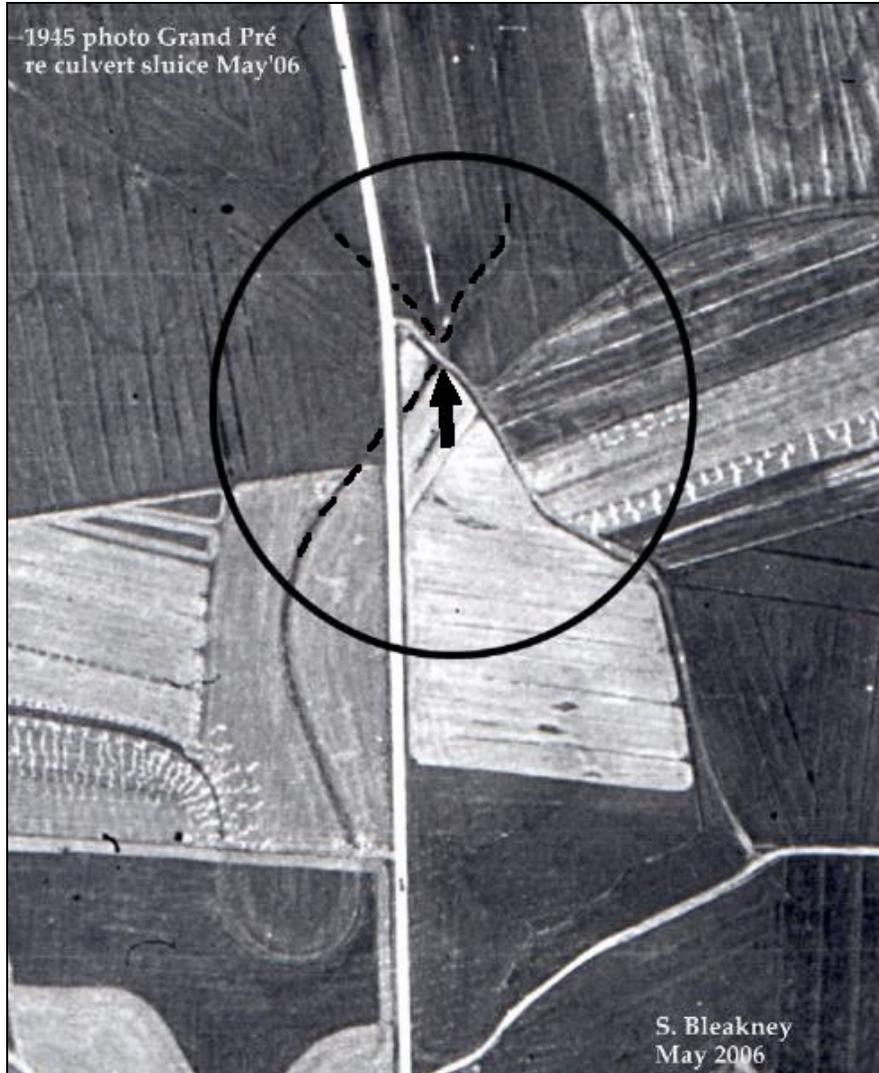
Figure 5: The roadway (white line) under which the sluice was discovered as seen from the air in 1945. The black arrow indicates the find location at the point where the road crosses the creek bed (the course of the creek is indicated by dashed lines). North at top. Photo Source: Sherman Bleakney.

Bleakney's model of the Acadian dyking sequence at Grand-Pré benefited from a surviving survey of the marsh drawn up in 1760 by John Bishop (2004, 75).⁶ This large scale plan is the single most important source available for understanding the Acadian dyking system at Grand-Pré, and it plots not only the network of dyke walls as they existed in the mid-18th century, but also the various roadways and field divisions. By reconsidering our site location in light of this 1760 plan, with one eye still on Bleakney's model, we immediately learn a great deal: our sluice is located near the intersection of five roads, and at a point where one of these roads crosses a creek. **Figure 4** displays a rough overlay of the historical map with a 1967 aerial photograph. The farm road under which our sluice was found remains in use to this day, although it shows up best in an aerial photograph from 1945 (**Figure 5**).

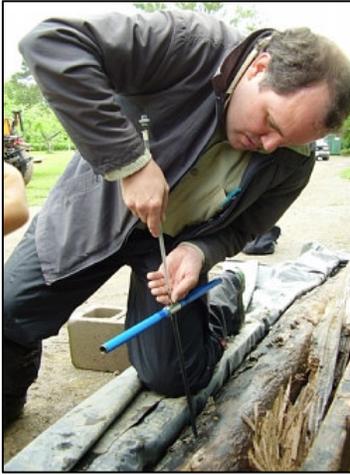
Figure 6: André Robichaud extracting a tree ring sample from one of the posts.

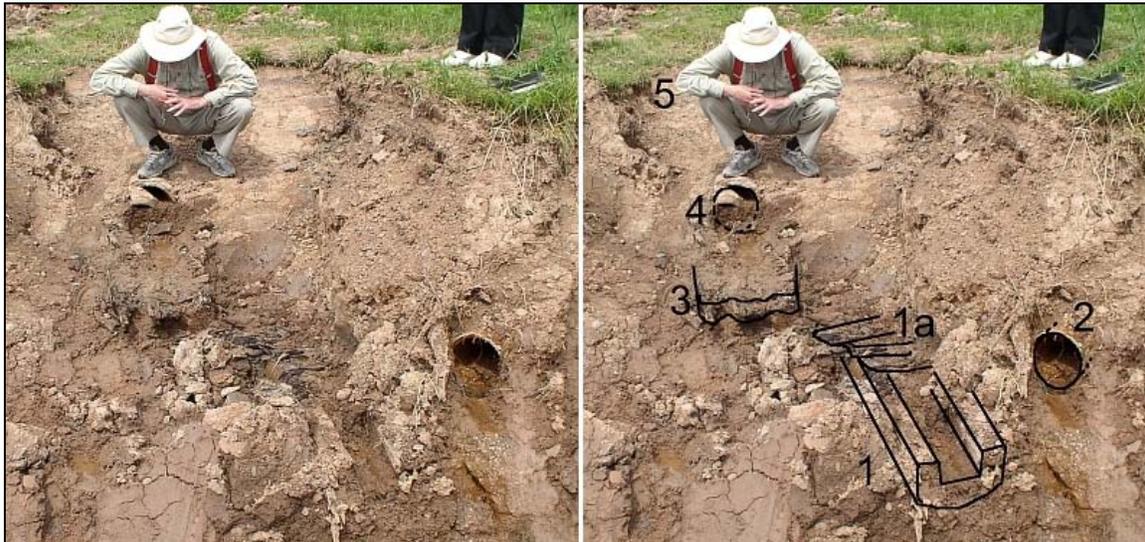
Figure 7: The side of the excavated drainage ditch, revealing its archaeology, as it appeared on 26 May, 2006, camera facing north. Here we may see (1) the sluice, with its broken end exposed; (1a) elements of the poorly preserved plank cover of the sluice; (2) a modern plastic drain pipe; (3) portions of another wooden feature (identity unknown at the time of this visit); (4) a concrete drain pipe bedded on top of the mysterious wooden feature; and (5) Dr. Sherman Bleakney (for scale).

oldest and deepest element of these works was the sluice itself (Figure 7, #1), the top of which was found at about 1m below the present marsh surface. By tracing the grain of the wood through the clay, it was possible to observe that some of the planks covering the sluice also remained in situ (Figure 7, #1a), but in a very poor state of preservation. Just above the sluice, to the east, the broken end of a plastic pipe dribbled water (Figure 7, #2). The recent installation of this pipe must have come precariously close to the sluice, but appears to have not even grazed it.⁷ Curiously, adjacent to the sluice to the west, bedded slightly higher in the profile, additional wooden elements could be seen (Figure 7, #3). This was a cause of much speculation. Finally, a concrete pipe, another fairly recent installation, though probably not as recent as the plastic pipe, appeared to be bedded almost directly on top of these curious wooden elements (Figure 7, #4). The potentially problematic component of this crude cross section was the additional wooden elements (#3), which frankly puzzled us at the time. Just a little more confidence in our deductive reasoning to date might have provided the answers, but I confess it was induction that ultimately told the tale.

There are two significant variations in this overall pattern that deserve note: one to the west of the sluice and another directly above it. To the west of the sluice, and separated by three corduroy poles, a 20cm-wide plank was discovered at the same level as the corduroy. Abutting it, again to the west, a crude channel had been formed by a series of smaller planks, all badly degraded (see **Figure 10**, 'second wooden drain'). Stratigraphically, this feature, which amounted to yet another water channel, was demonstrably more recent than the main sluice. It was located at the level of the corduroy (and higher), and the brushwork overlying the corduroy ran underneath it. This interpretation gained support by the discovery of a single wire nail associated with the channel. Traces of this structure ran the whole length of the sluice, but appear to have been badly damaged by the installation of the concrete pipe (#4 in **Figure 7**).

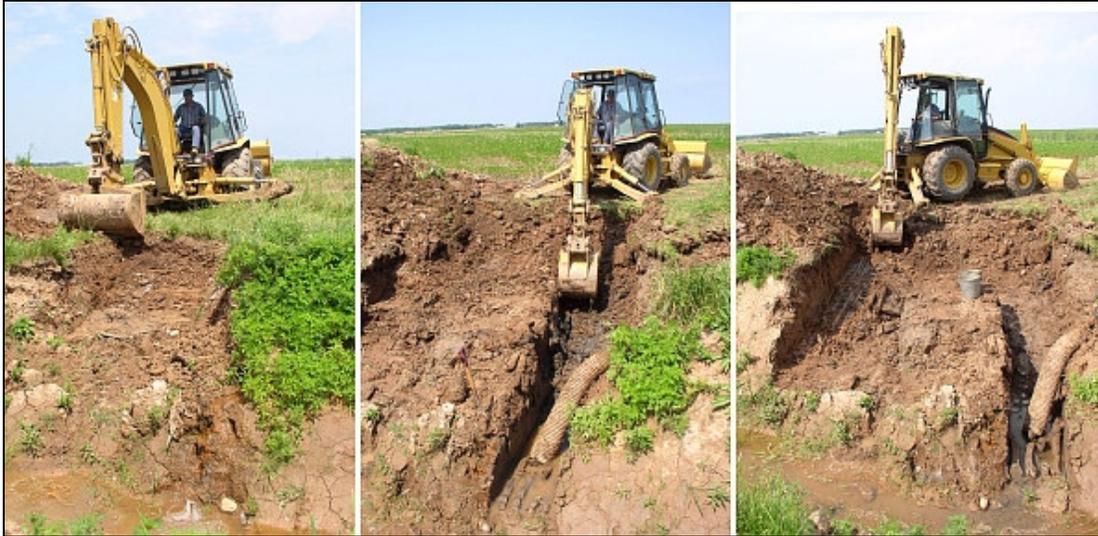
Figure 8: Three photographs showing the progress of mechanical excavation (left to right) to determine the extent of the in situ sluice. Camera facing north.

The salvage excavation commenced on 14 July. A backhoe removed the overburden and delineated the archaeology (**Figure 8**) and the rest of the day was spent on detail work with hand tools.⁸ It soon became apparent that the mysterious wooden elements immediately west of the sluice were mirrored by another set above the sluice on the east side. Further detailed excavation on 15 July revealed this to be a series of poorly

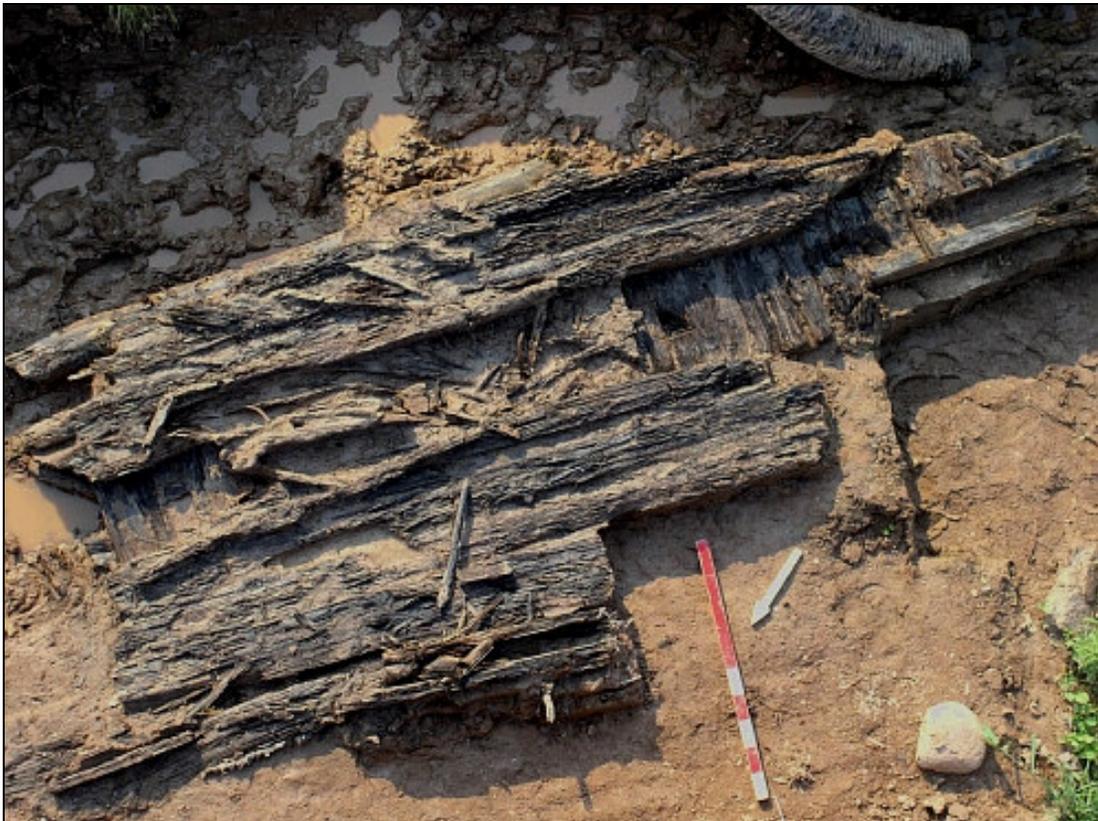
Figure 9: The cleaned sluice feature prior to the removal of the corduroy road remnants.

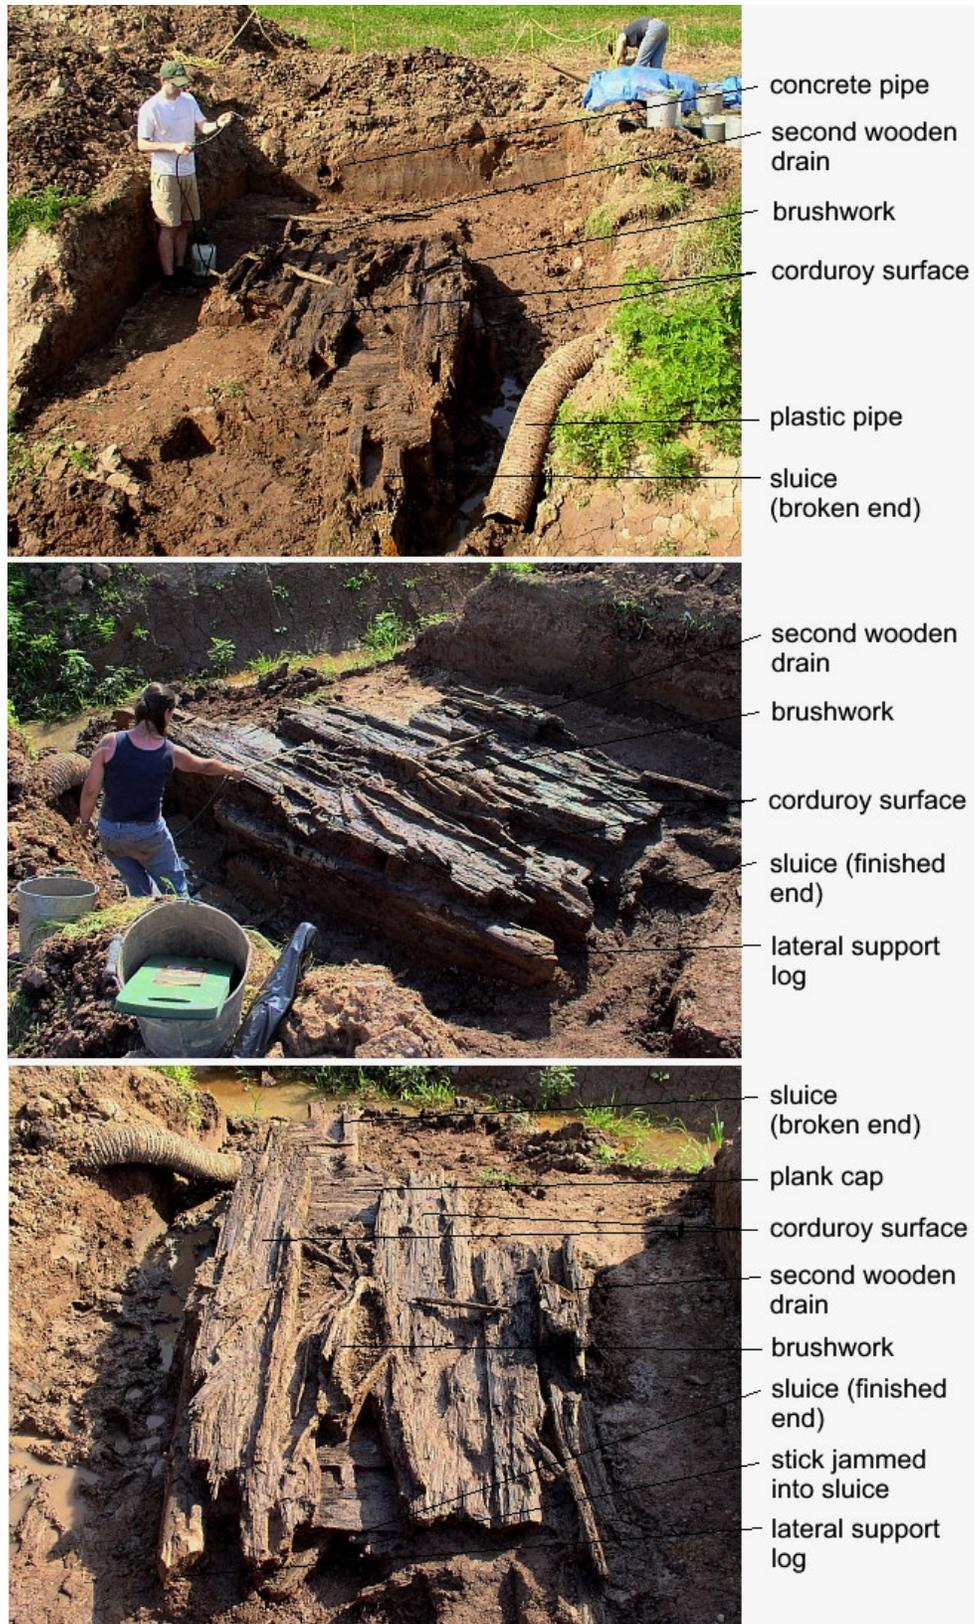
Figure 10: The sluce and corduroy features at the end of the initial phase of excavation. (Top) with Robert Shears (camera facing north); (Middle) with Sara Beanlands (camera facing southwest); (Bottom) camera facing south.

preserved poles bedded horizontally just above, and parallel to, the sluice. The discovery of these poles resolved any lingering question as to the function of this sluice, for they had clearly been laid down above the sluice to form a hardened surface over which one could travel. In other words, we were looking at the remains of a corduroy road surface (**Figure 9**). An additional set of labelled close-up images is presented as **Figure 10**.

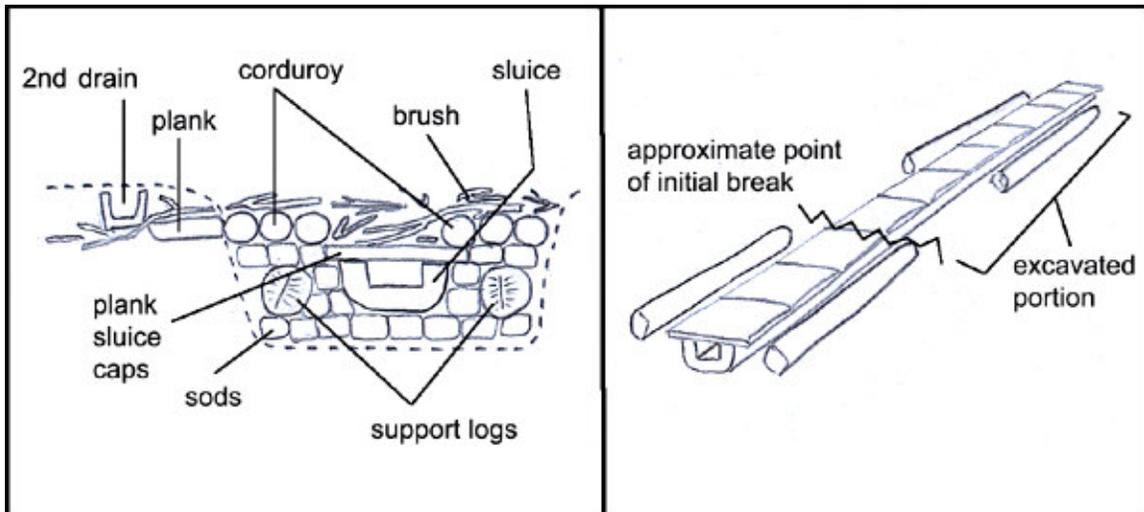
Figure 11: Sketch of the sluice and associated features. The views are from the south (l) and southeast (r), and are not drawn to scale. It should be noted that the positions of the two southern support logs are conjectural, as we were not on site to observe their extraction. Material beneath the dashed line in the left-hand image was not excavated.

Hand excavations provided an opportunity to investigate the stratigraphic relationship between the various elements of the sluice construction.⁹ **Figure 11** provides a sketch of these elements. Plan views with the corduroy surface in place and with the corduroy removed are shown in **Figure 12** and **Figure 13** respectively.

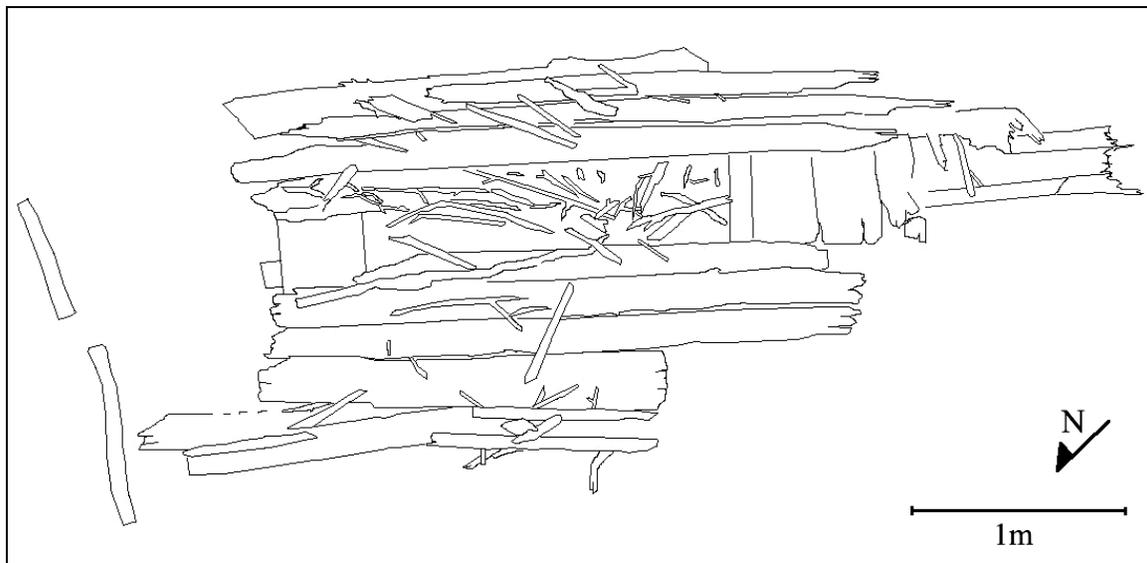
Figure 12: Plan view of the sluice with the corduroy surface still in place. Brushwork can be seen overlying the corduroy and in the gap in the corduroy surface directly above the sluice.

Directly above the sluice we found no corduroy poles. They had either never been installed or had been installed but later removed. In their place, a dense mat of brushwork was encountered, with the spruce needles still reasonably well preserved. I can think of at least one good reason for this deviation to have occurred here (more on this below), and it probably relates to an anomaly in the wood planking covering the sluice approximately 1.8m from its broken end. Here, a triangular hole had been cut into the planked surface of the sluice, apparently with an axe. The result is a small weeping drain that would have channelled water from the corduroy surface directly down into the sluice channel.

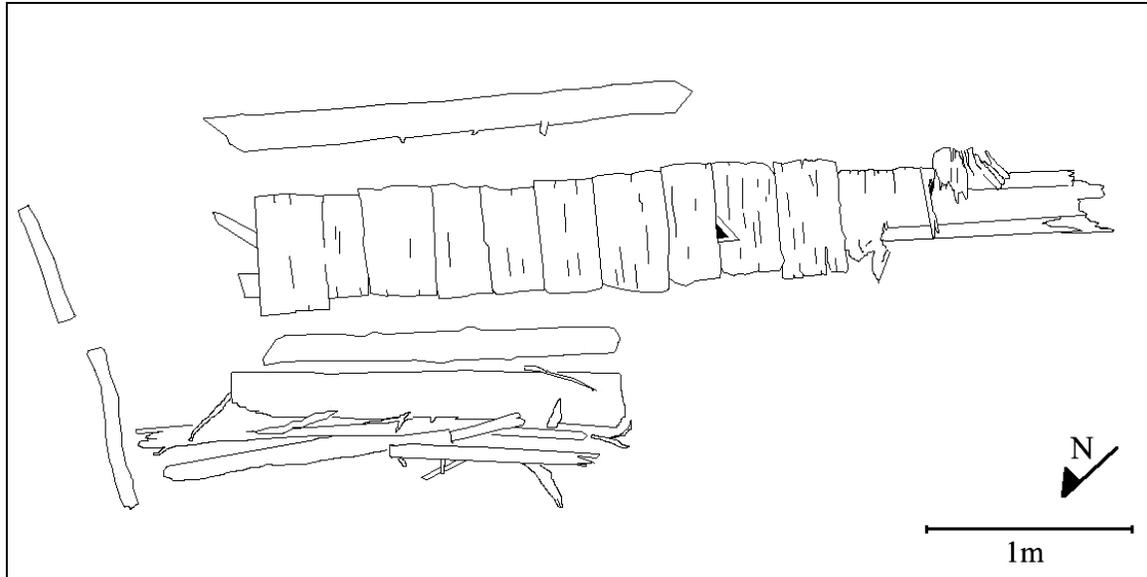
Figure 13: Plan view of the sluice with the corduroy surface removed. The cleaning process reveals the weeping drain cut into the planks covering the sluice (centre right).

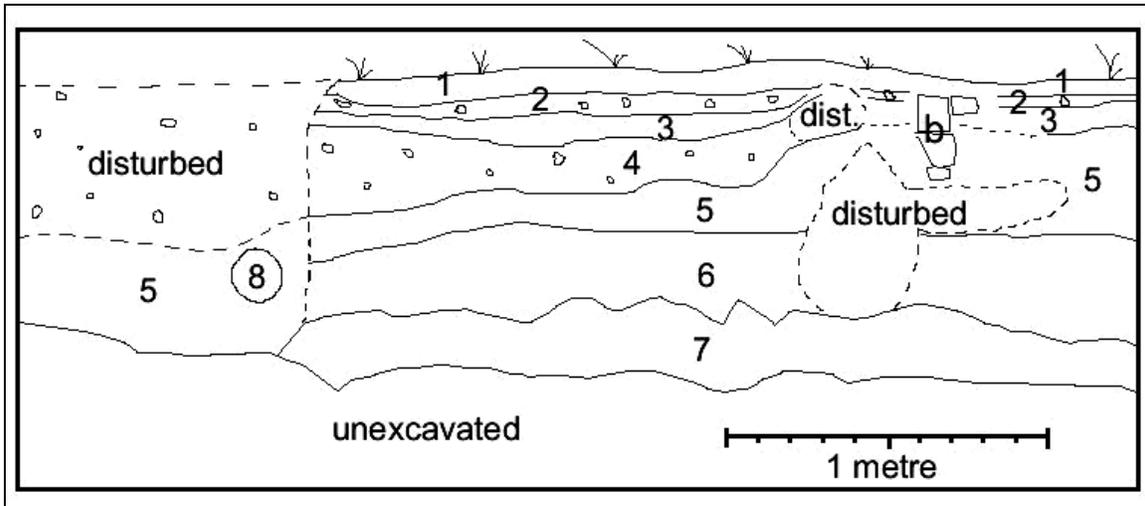
Figure 14: North profile. (1) Sod; (2) crushed rock; (3) brown clay; (4) crushed rock; (5) red clay; (6) grey clay; (7) red clay; (8) concrete pipe. Sod bricks are labelled 'b'. Disturbed areas represent portions of the profile that collapsed during machine excavation.

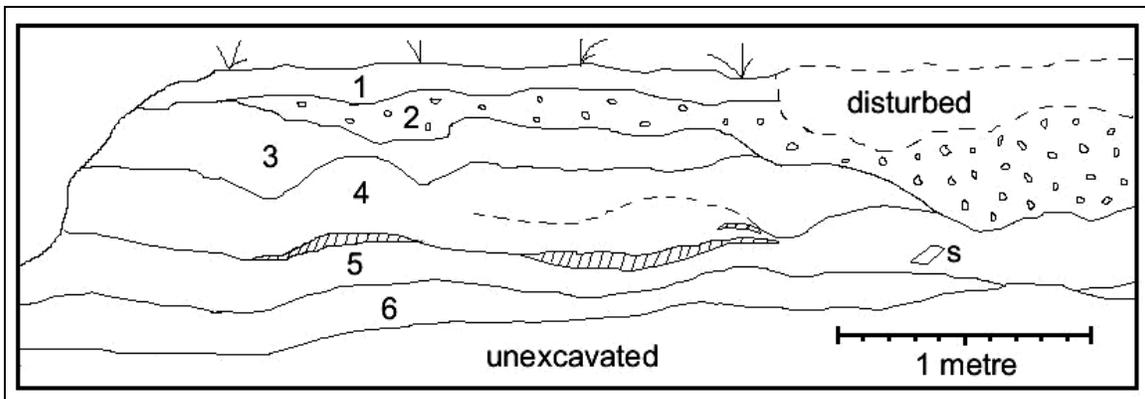
Figure 15: West profile. (1) Sod; (2) crushed rock; (3) red clay, blocky structure; (4) brown clay; (5) grey clay; (6) red clay. Hatched layers represent traces of wood likely associated with the western end of the brushwork or decayed corduroy. The disturbed area represents a portion of the profile that collapsed during machine excavation.

It stands to reason that if the wooden elements picked up in the west profile (hatching, Figure 15) relate to the brushwork and/or corduroy overlaying the sluice, then the layers immediately beneath (#s 5 and possibly 6) represent either natural marsh development beside the creek at the time of installation, or fill material placed within it during installation. The fact that the north profile was so heavily disturbed by subsequent earthmoving prevents us from picking up the shape of the original creek bed. The fact that no evidence of it was found rather suggests that the original creek bed was broader than our excavations. If this is the case, then virtually all of the material we are seeing in the profiles is fill (indeed some of it is fill within fill).
