historic resources survey

site no. 317

1. BUILDING NAME: Common: residence Historic: Jone, Eliakim, House
2. TOWN/CITY: _____ VILLAGE: Mewow COUNTY: _____
3. STREET & NUMBER (and/or location): 1673 Stafford Rd
4. OWNER(S): _____ PUBLIC / PRIVATE
5. USE: Present: residence Historic: _____
6. ACCESSIBILITY TO PUBLIC: Exterior visible from public road: yes no
Interior accessible: yes, explain no

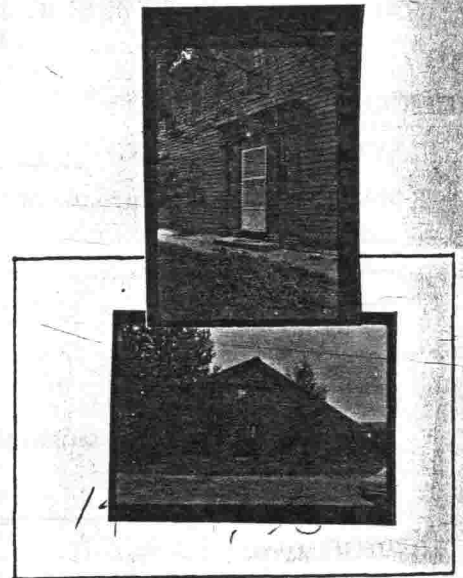
PHOTOGRAPH

- ① balanced 9-window facade
- ② corner pilasters w/ triglyphs above capital
- ③ fully pedimented gable end w/ modillions, hemispheric light in tympanum
- ④ 4/6 sash, appears new
- ⑤ entry framed by two pair of pilasters on either side of 3/3 sidelights, full entablature above
- ⑥ concrete foundation, new

photographer: JD
date: 9/78 view: North, entry detail
negative on file: _____
