GEOLOGY AND THE DEVELOPMENT OF UPSTATE NEW YORK'S DISTINCTIVE COBBLESTONE ARCHITECTURE

From the New York State Geological Association Field Trip Guide, 72nd Annual Meeting, p. 91-111

D. BROOKS MCKINNEY
Department of Geoscience
Hobart and William Smith Colleges
Geneva, NY 14532
Email: dbmck@hws.edu

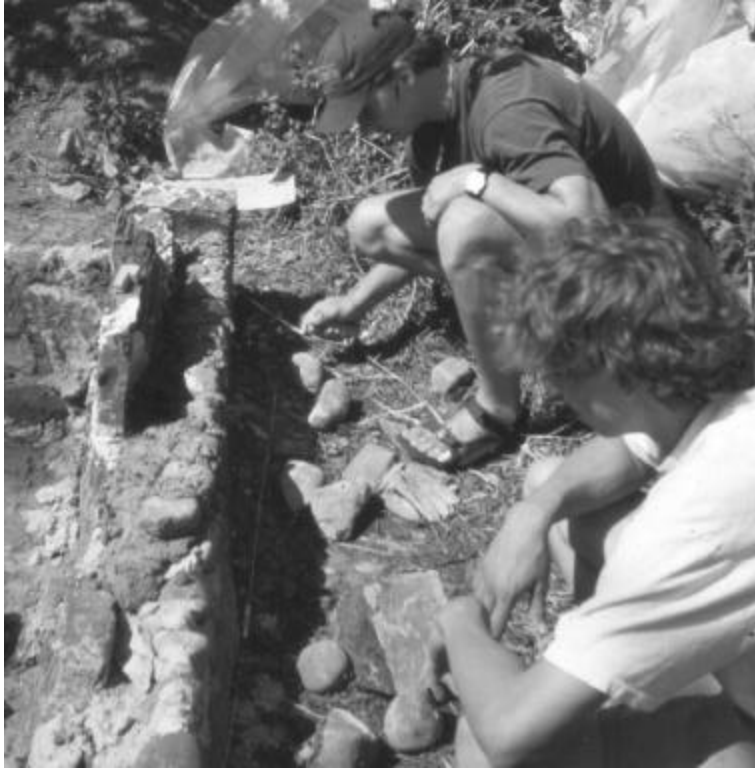
Figure 3. A small cobblestone wall under construction. Note the “backing stones” that form the back of the wall and the line of cobbles along the front. In between is the “trough” which will later be filled with rubble and mortar in advance of starting the next course.

Figure 3 shows a small cobblestone wall under construction. Working from a foundation of large blocks, a set of backing stones for the inside wall is laid up and the quoins are laid true and square. To “fill” the space between the quoins with cobblestones, a thick bed of mortar is laid down. Individual size-sorted cobbles are then placed on this mortar bed so that their upper surfaces define a roughly horizontal line and the ends that project outward from the wall are flush with a guide string strung between the corners of the two quoins. These cobbles are placed so that they have approximately 2 to 4 cm gap between them. Once the stones are thus arranged, the mason fills the gaps between stones with mortar. As the mortar is thixotropic, this is best done by flinging a wad of mortar into the gap with a small trowel; repeated flings fill the gap up to the height of the stones on either side. With the gaps between cobbles filled, the joints are formed using a flat pointing trowel. The vertical joints across the entire wall are formed first. Using upward strokes, first on one and then the other side of the joint’s center line, the mason creates vertical to inward sloping surfaces that meet as a broad V. Typically this is broader at the base than the top. Once all the vertical joints for a course have been formed, the mason shapes the upper surfaces of the two angled surfaces that will form the horizontal joint at the base of the course. This upper surface is created by running the trowel horizontally along the base of the stones, pressing inward and downward to create a mortar “shelf” that is angled down and away from the wall at roughly a 45° angle. Finally, the mason uses a slicing motion to cut away the excess mortar along this shelf and in the

process forms the face of the lower part of the horizontal joint, a surface that slopes inward and down. The visual “line” of the joint is formed by the intersection of the two surfaces; while contact of the upper and lower surfaces of the joint with the cobbles may be very irregular, the line of the joint is produced by the intersection of the joint’s upper and lower surfaces and its linearity and horizontality is limited only by the mason’s skill.

Completion of the joint work for a course leaves an irregular trough between the backing stones and the stones laid up as the horizontal cobblestone course. This trough is important because it compensates for the different sizes of the cobblestones—larger stones can extend farther back into the trough than shorter ones. Such larger stones help to strengthen the final wall by “tying” the cobblestone work to the wall’s interior. After one or two courses of cobblestone is laid, this trough is filled with mortar and waste stones, rocks that are not well sized shaped, or colored for the cobblestone exterior. Thus, cobblestone walls are a type of rubble-filled mortar construction.

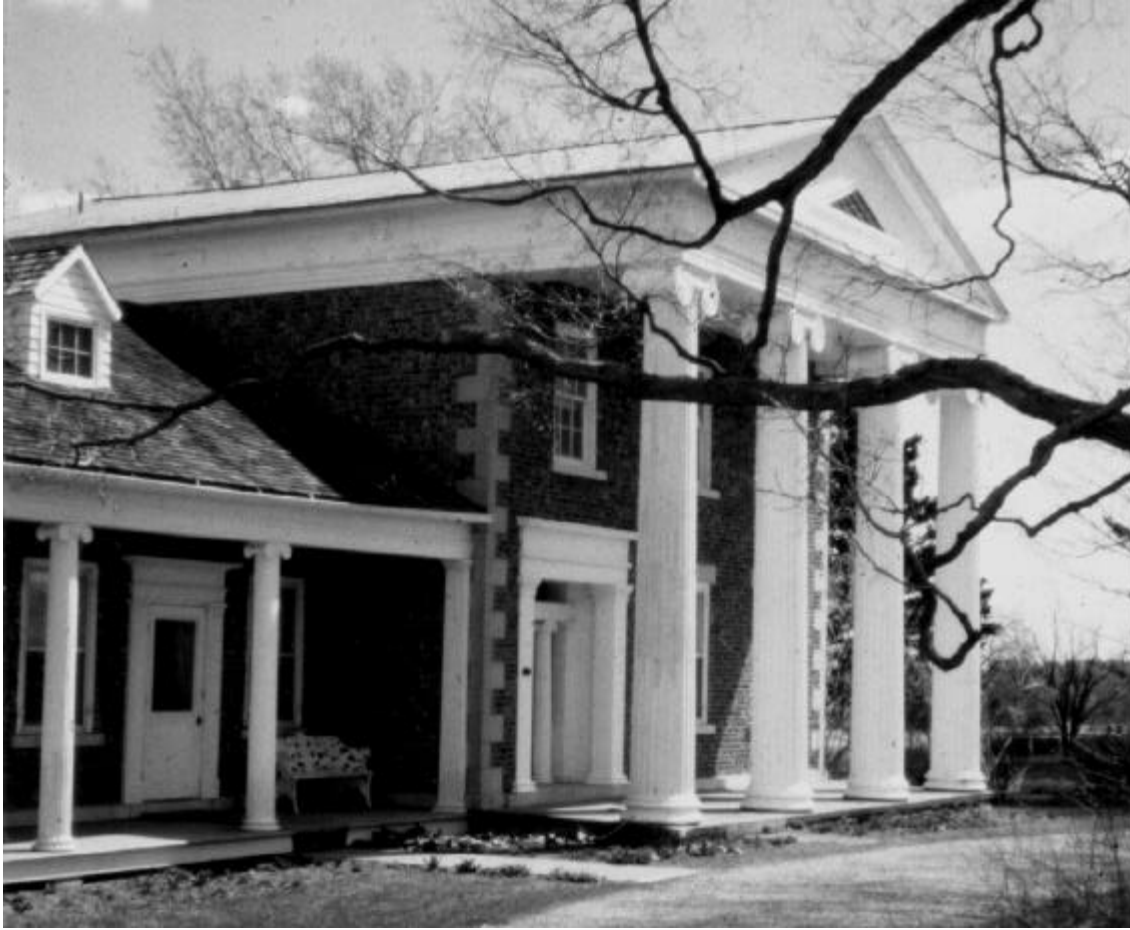
This house is an excellent example of a Greek Revival cobblestone (Figure 5). It was built over a period of three years, beginning with the north wing in 1835 and completed in 1838. Key features identifying this as a Greek Revival are the portico with Ionic columns, the wide cornice moldings which simulate the entablature of a Greek temple, the recessed doorway, and the massive lentil over the doorway. Features to examine and discuss: lithologies of the cobblestones, cut-stone components and their tool marks, character of mortar joints, variations in technique from the front to the back of the house, assignment to one of the cobblestone periods (early, middle, late).

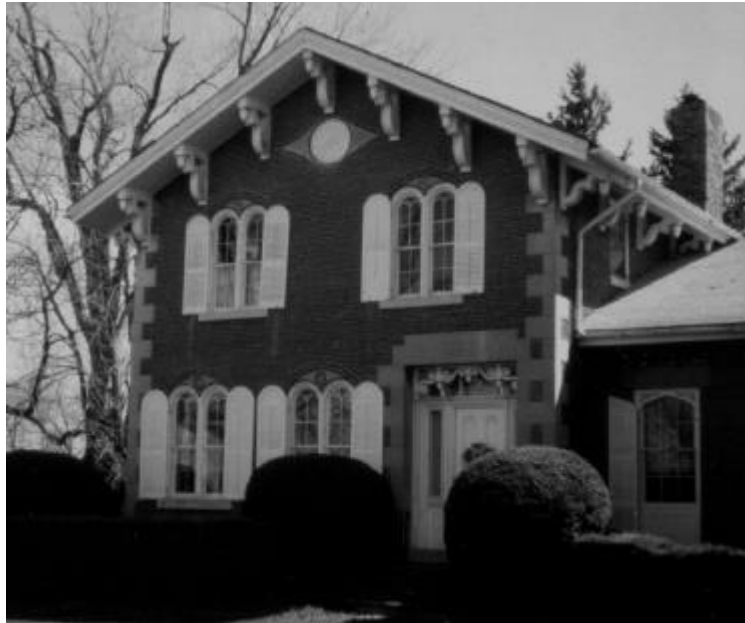
STOP 3. RIPPEY HOUSE, LAKE-WASHED ITALIANATE HOME, 1854

This home is made of lake-washed cobbles and was built in the Italianate style very late in the era of cobblestone construction. The features which identify it as Italianate are the shallow roof angles, the deep eaves, the decorative brackets supporting the eaves, and the paired windows with rounded arches. The Italianate style called for “compressed” vertical elements, tall and relatively thin windows, for example. After 1850, improvements in glass-making technology allowed these windows to have a few large panes of glass, in contrast to the small panes used in earlier styles. The other common Italianate style, though though rarely made of cobblestones, is the “cube and cupola,” a two story box like house with a shallow-angled roof that rises in four panels to a central cupola. Features to examine and discuss: lithology, size and sorting of the cobblestones, nature of the mortar joints, quality of mortar work around the windows, comparisons with Barnes house, assignment to one of the cobblestone periods (early, middle, or late).

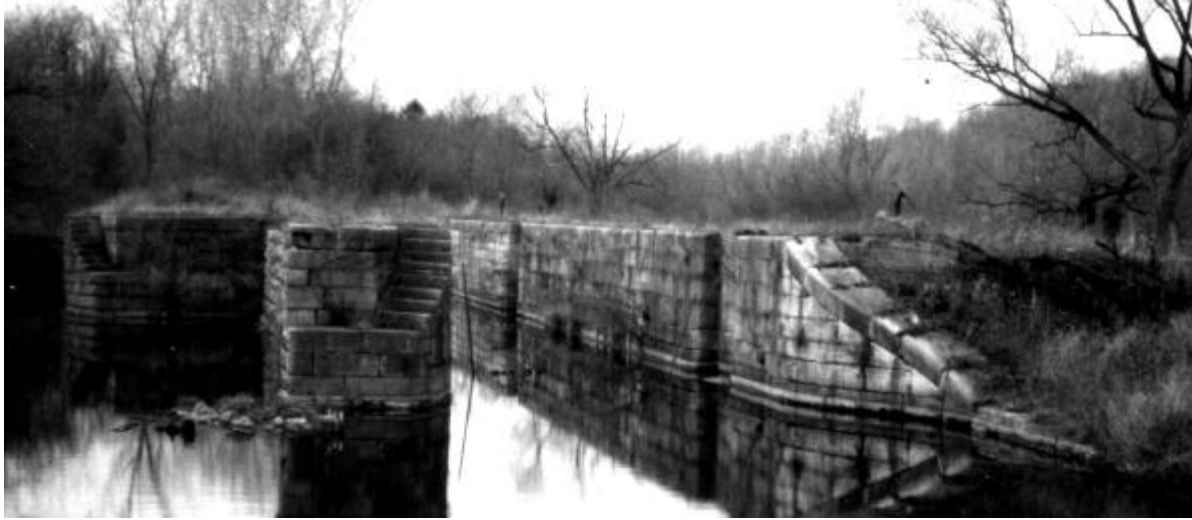
STOP 10. OLD LOCK 56 OF THE ERIE CANAL

The significance of this stop is two fold. First, it provides a fine setting in which to review the importance of the Erie Canal to the economic prosperity it helped to produce, and of which cobblestone farm houses are one manifestation. Second, it is a good place to review the “Erie Canal theory,” the idea that cobblestones were built by unemployed masons who had been imported to build the canal. The disparities between the type of construction used on this lock and cobblestone construction should be quite clear.
